Date: June 23, 2023

From: Andy Zdon, P.G., CEG, C.Hg.

Subject: Proposed Ash Meadows Lithium Exploration

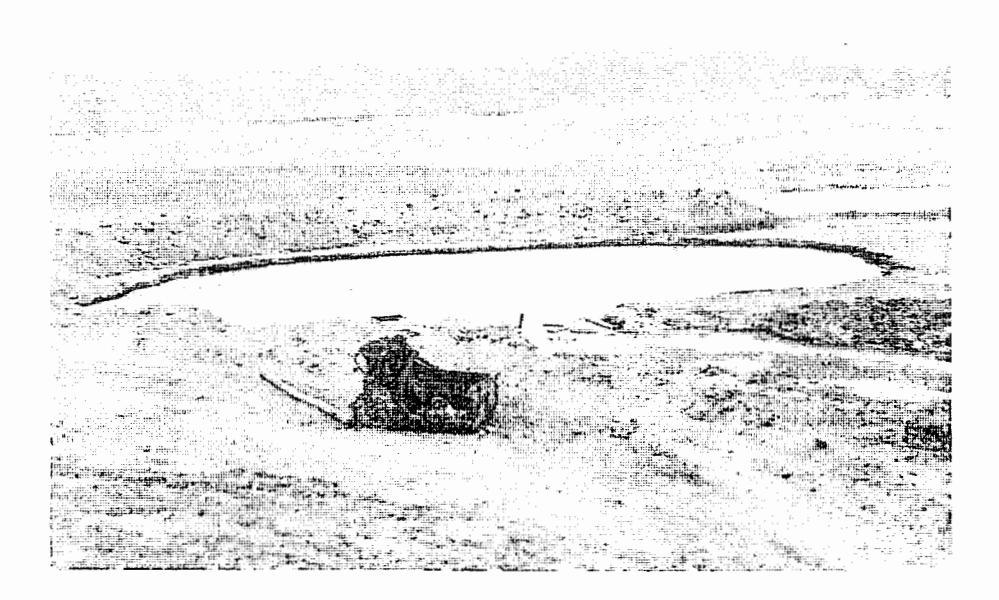
Photograph #1

Some months later a circular area surrounding the cemented well head collapsed, due to subsurface erosion, and a pond approximately 75 feet in diameter ultimately resulted. (See photo #1.)

View to northeast showing pond resulting from collapsed hot water well. Clay dike constructed around north side of pond prior to gravel fill being placed.

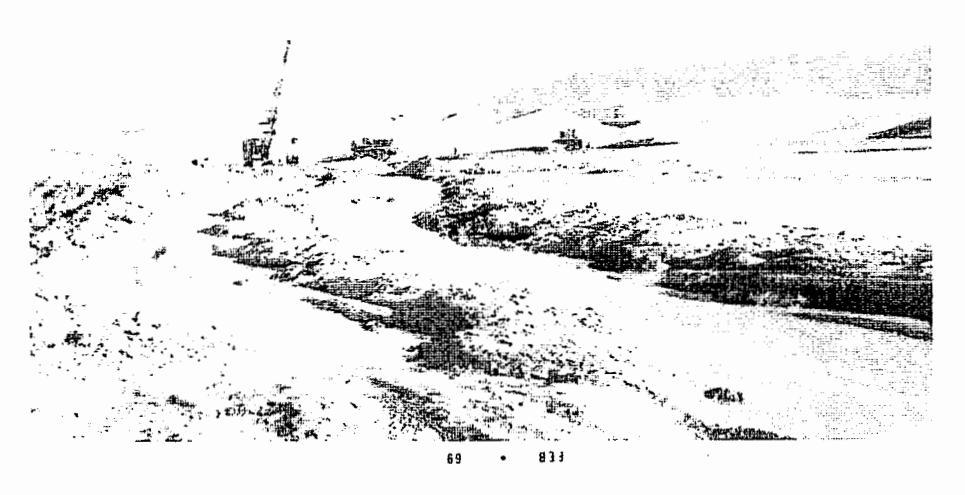
Photograph #2

View to north showing south side of dike enclosing pond and draimage channel.

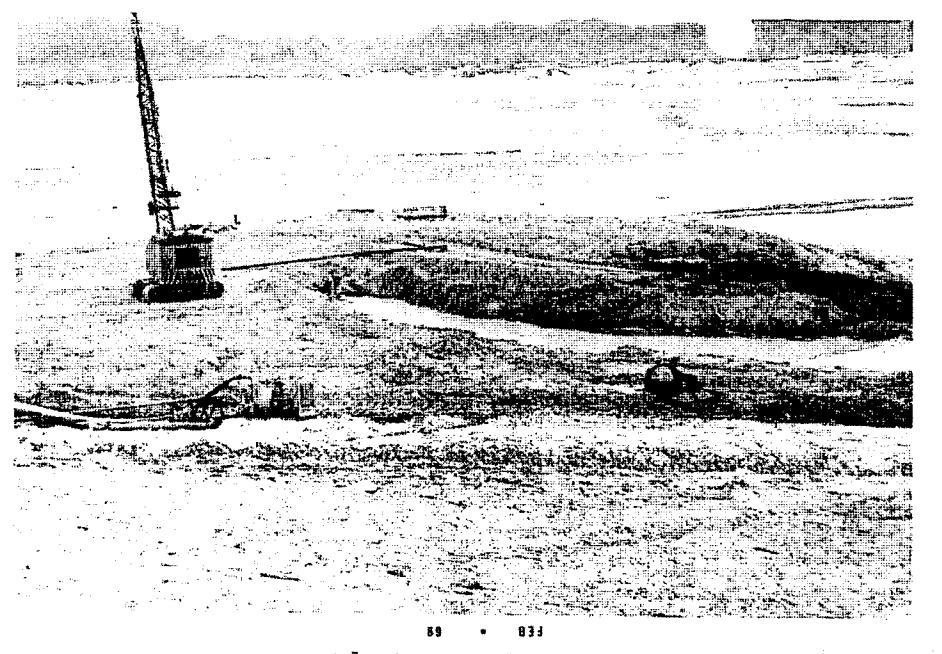
Photograph #3

with a clam shell bucket. Approximately 9,000 additional yards of pit-run gravel were dozed into the cavity around the casing, and the impervious clay dike, consisting of more than 3,000 yards, was completed around the gravel fill. (See photo #3 and drawing #1.) In the process of filling the cavity, the casing and the gravel fill subsided somewhat and it was necessary to provide extensions to the casing. At the completion of the fill work, 96 feet of twenty inch casing had been placed in the hole.

View to east showing gravel fill surrounding casing, enclosing clay dike and drainage channel.

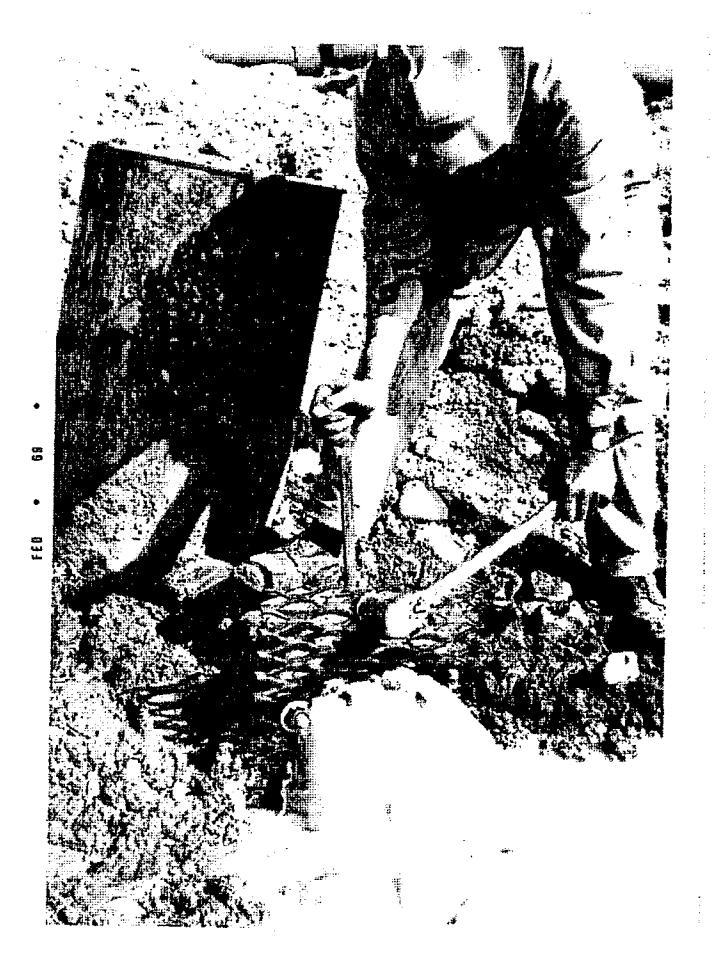
Photograph #4

At present the entire artesian flow is being conducted to the surface through the twenty inch casing. The top of casing is capped and water discharges from its side through an eight inch "L" fitted with a flange and a screen. (See photo #4.) DEC • 68

Artesian flow being discharged through "8" L leading from side of twenty inch casing.
